**Flood Control Project Maintenance
Levee Inspections**

2020 Channel Summary Report

Fairfield Suisun Sewer District

Laurel Creek

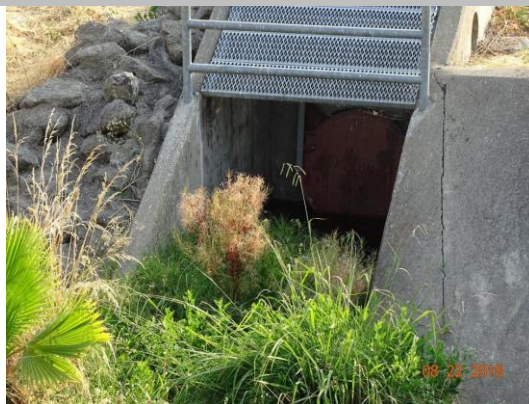
Photo 1 of 1 : CH_2020_NA0035_15_91_20200715_00025.jpg

Inspector Comments: Minimal debris is present, however nothing appears to obstruct the function of the gate.

View of the gate located on the upstream side on the left bank of the channel. Summer 2018.

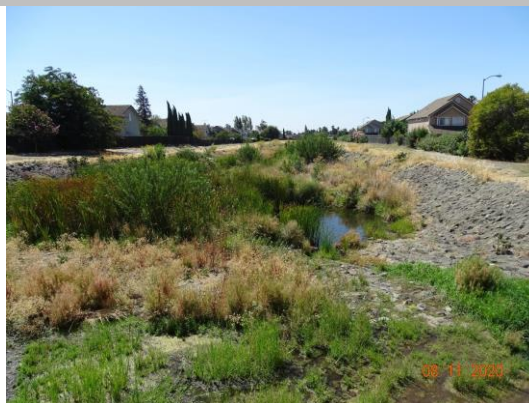
Photo 1 of 1 : CH_2020_NA0035_15_6_20200812_00043.jpg

View of the channel looking downstream. Summer 2020.

Inspector Comments: Vegetation should be cleared from the channel.

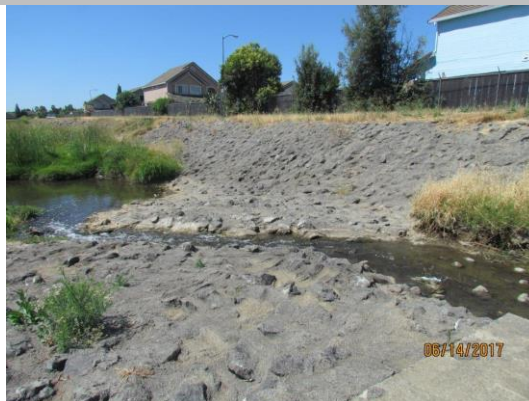
Photo 1 of 1 : CH_2020_NA0035_15_9_20200715_00004.jpg

Rating **	A	Issue No.	9	GPS Lat/Long
Issue Type +	Ma	Location *		38.279937 °
Category	Rivers, Channels & Designated Flood			-122.018354 °
Item	Revetments			
DWR ID	DWR_NA0035_15_c_2012_9			
Action/Comments				
Inspector Comments: Existing riprap protection is properly maintained and is undamaged. Riprap clearly visible.

View of revetment on the right bank looking downstream towards Pilot Channel. Summer 2017.

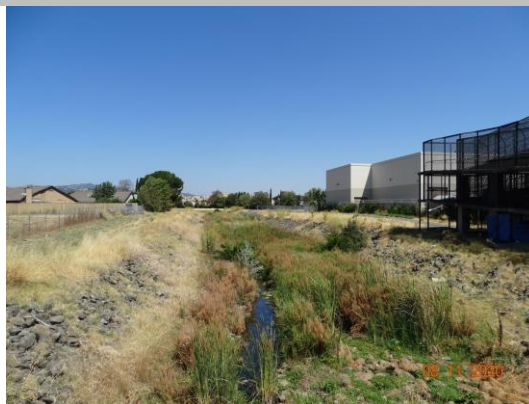
Photo 1 of 1 : CH_2020_NA0035_15_11_20200812_00042.jpg

Rating **	A	Issue No.	11	GPS Lat/Long
Issue Type +	Ma	Location *		38.272625 °
Category	Rivers, Channels & Designated Flood			-122.015993 °
Item	Vegetation & Obstructions			
DWR ID	DWR_NA0035_15_c_2012_11			
Action/Comments				
Inspector Comments: Minimal, scattered obstructions or vegetation. The flow is not impeded.

View of the channel looking upstream. Summer 2020.

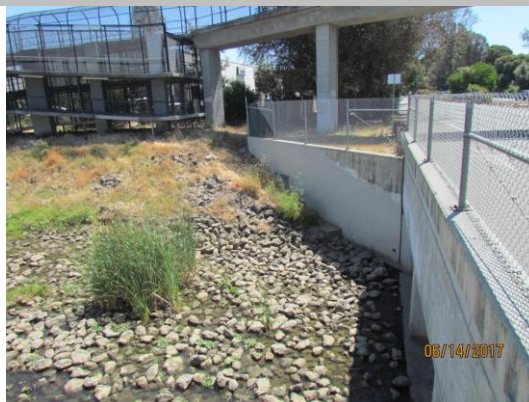
Photo 1 of 1 : CH_2020_NA0035_15_14_20200715_00006.jpg

Inspector Comments: Existing riprap protection is properly maintained and is undamaged. Riprap clearly visible.

View of revetment on left bank, looking upstream. Summer 2017.

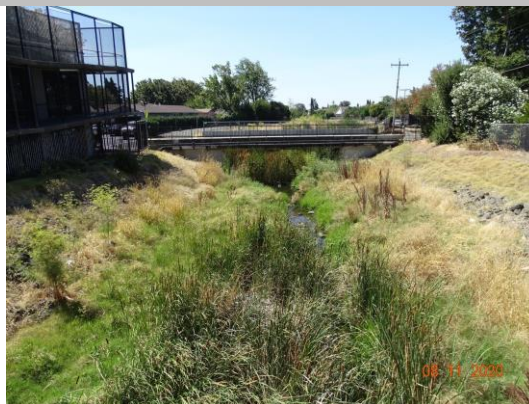
Photo 1 of 1 : CH_2020_NA0035_15_16_20200812_00041.jpg

Rating **	A	Issue No.	16	GPS Lat/Long
Issue Type +	Ma	Location *		38.272633 °
Category	Rivers, Channels & Designated Flood			-122.016110 °
Item	Vegetation & Obstructions			
DWR ID	DWR_NA0035_15_c_2012_16			
Action/Comments				
Inspector Comments: Minimal, scattered obstructions or vegetation. The flow is not impeded.

View of the channel looking downstream. Summer 2020.

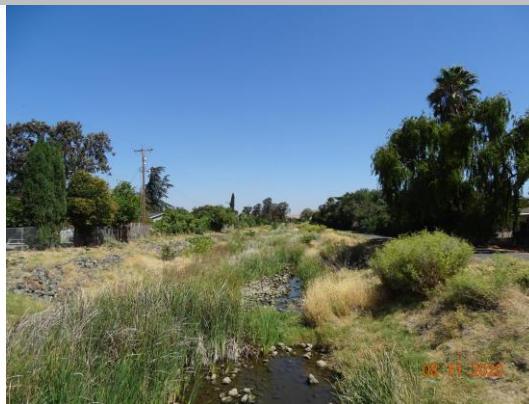
Photo 1 of 1 : CH_2020_NA0035_15_21_20200812_00040.jpg

Inspector Comments: Minimal, scattered obstructions or vegetation. The flow is not impeded.

View of the channel looking upstream. Summer 2020.

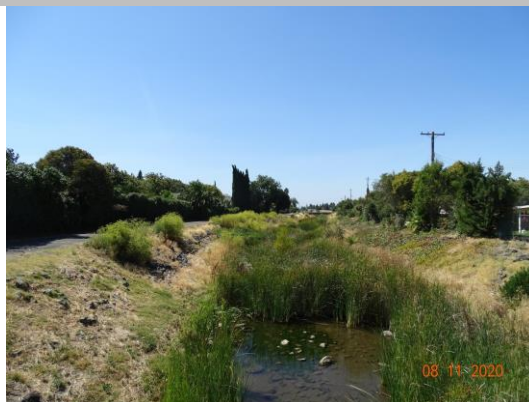
Photo 1 of 1 : CH_2020_NA0035_15_26_20200812_00039.jpg

Inspector Comments: Minimal, scattered obstructions or vegetation. The flow is not impeded.

View of the channel looking downstream. Summer 2020.

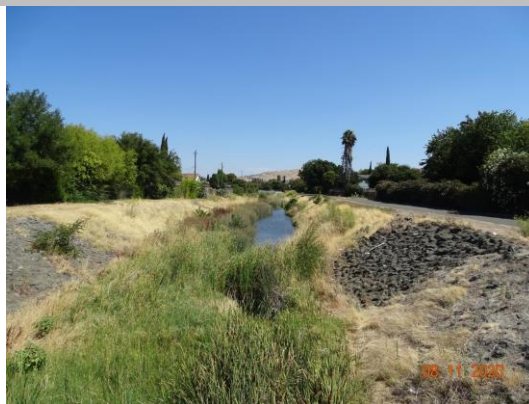
Photo 1 of 1 : CH_2020_NA0035_15_31_20200812_00038.jpg

Rating **	A	Issue No.	31	GPS Lat/Long
Issue Type +	Ma	Location *		38.265401 °
Category	Rivers, Channels & Designated Flood			-122.018316 °
Item	Vegetation & Obstructions			
DWR ID	DWR_NA0035_15_c_2012_31			
Action/Comments				
Inspector Comments: Minimal, scattered obstructions or vegetation. The flow is not impeded.

View of the channel looking upstream. Summer 2020.

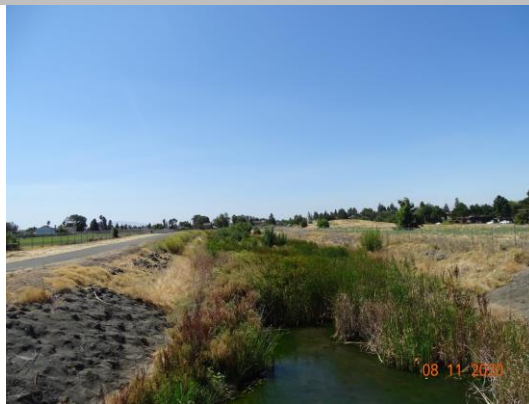
Photo 1 of 1 : CH_2020_NA0035_15_36_20200812_00037.jpg

Inspector Comments: Minimal, scattered obstructions or vegetation. The flow is not impeded.

View of the channel looking downstream. Summer 2020.

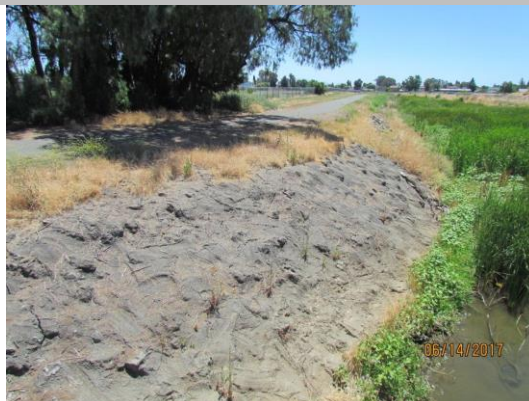
Photo 1 of 1 : CH_2020_NA0035_15_39_20200715_00012.jpg

Rating **	A	Issue No.	39	GPS Lat/Long
Issue Type +	Ma	Location *		38.265401 °
Category	Rivers, Channels & Designated Flood			-122.018316 °
Item	Revetments			
DWR ID	DWR_NA0035_15_c_2020_39			
Action/Comments				
Inspector Comments: Existing riprap protection is properly maintained and is undamaged. Riprap clearly visible.

View of revetment on left bank, looking downstream. Summer 2017.

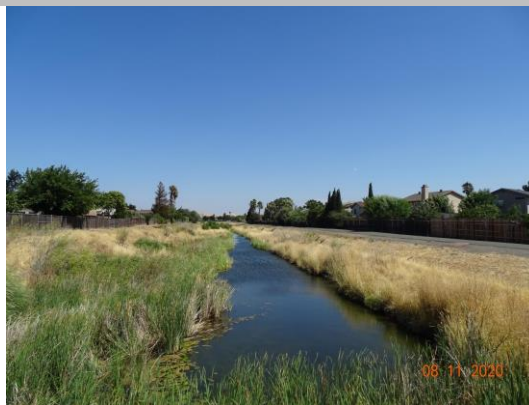
Photo 1 of 1 : CH_2020_NA0035_15_41_20200812_00036.jpg

Inspector Comments: Minimal, scattered obstructions or vegetation. The flow is not impeded.

View of the channel looking upstream. Summer 2020.

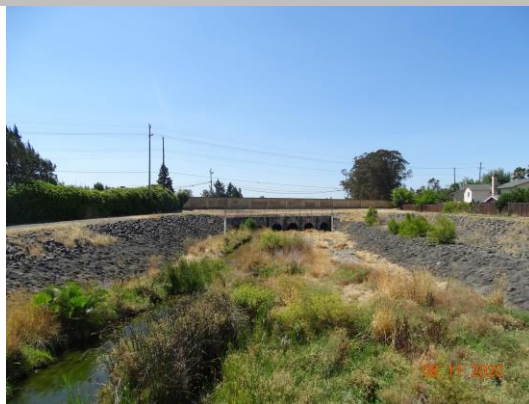
Photo 1 of 1 : CH_2020_NA0035_15_46_20200812_00035.jpg

Rating **	A	Issue No.	46	GPS Lat/Long
Issue Type +	Ma	Location *		38.259272 °
Category	Rivers, Channels & Designated Flood			-122.017533 °
Item	Vegetation & Obstructions			
DWR ID	DWR_NA0035_15_c_2012_46			
Action/Comments				
Inspector Comments: Minimal, scattered obstructions or vegetation. The flow is not impeded.

View of the channel looking downstream. Summer 2020.

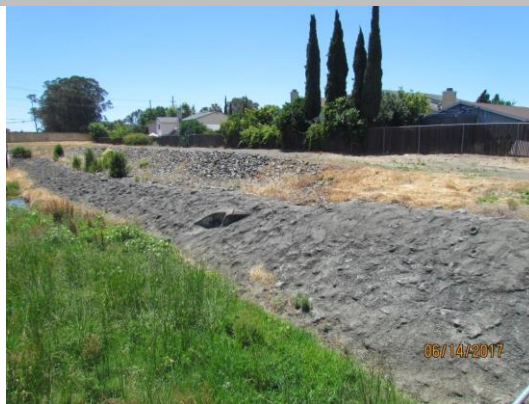
Photo 1 of 1 : CH_2020_NA0035_15_49_20200715_00016.jpg

Inspector Comments: Existing riprap protection is properly maintained and is undamaged. Riprap clearly visible.

View of revetment on right bank, looking downstream. Summer 2017.

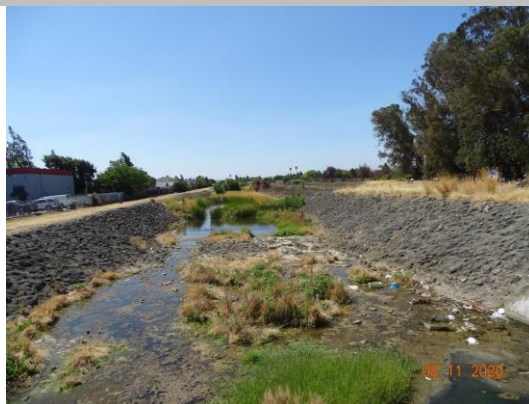
Photo 1 of 1 : CH_2020_NA0035_15_56_20200812_00034.jpg

Rating **	A	Issue No.	56	GPS Lat/Long
Issue Type +	Ma	Location *		38.257784 °
Category	Rivers, Channels & Designated Flood			-122.017733 °
Item	Vegetation & Obstructions			
DWR ID	DWR_NA0035_15_c_2012_56			
Action/Comments				
Inspector Comments: Minimal scattered obstruction or vegetation. The flow is not impeded.

View of the channel looking downstream. Summer 2020.

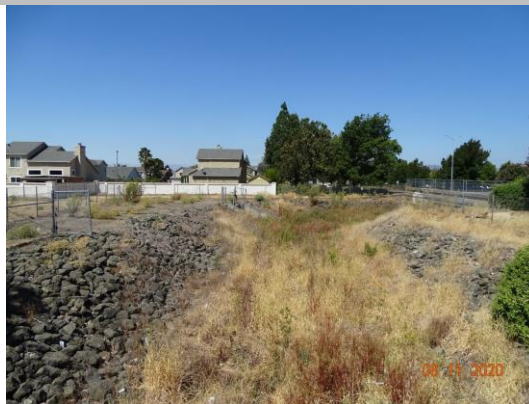
Photo 1 of 1 : CH_2020_NA0035_15_61_20200812_00033.jpg

Inspector Comments: Minimal scattered obstructions or vegetation. The flow is not impeded. This is an offshoot channel to Laurel Creek that is included within the Fairfield Streams O&M Manual.

View of the channel looking upstream. Summer 2020.

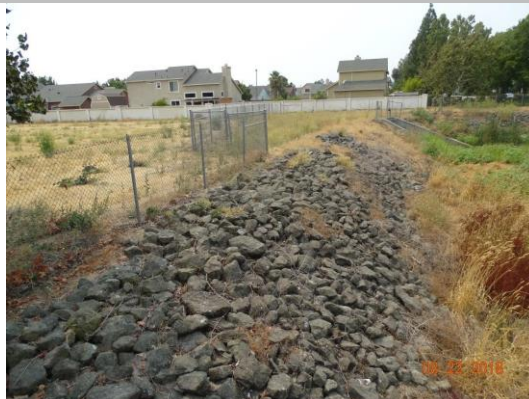
Photo 1 of 1 : CH_2020_NA0035_15_64_20200715_00019.jpg

Rating **	A	Issue No.	64	GPS Lat/Long
Issue Type +	Ma	Location *		38.253525 °
Category	Rivers, Channels & Designated Flood			-122.019984 °
Item	Revetments			
DWR ID	DWR_NA0035_15_c_2012_64			
Action/Comments				
Inspector Comments: Existing riprap protection is properly maintained and is undamaged. Riprap clearly visible.

View of the revetment on the right bank, looking upstream. Summer 2018.

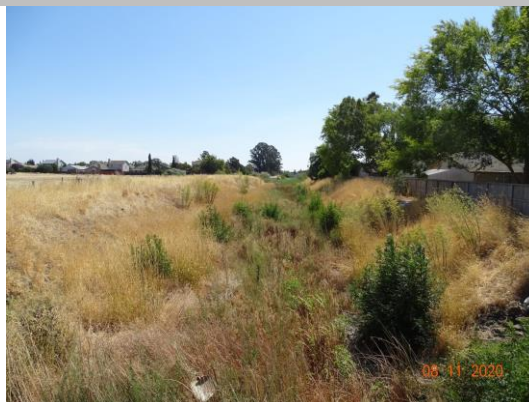
Photo 1 of 1 : CH_2020_NA0035_15_66_20200812_00032.jpg

Inspector Comments: Minimal scattered vegetation. Does not impede the flow.

View of the channel looking downstream. Summer 2020.

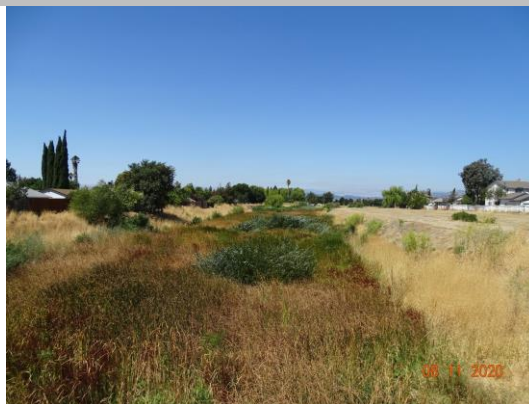
Photo 1 of 1 : CH_2020_NA0035_15_71_20200812_00031.jpg

Rating **	M	Issue No.	71	GPS Lat/Long
Issue Type +	Ma	Location *		38.253382 °
Category	Rivers, Channels & Designated Flood			-122.014862 °
Item	Vegetation & Obstructions			
DWR ID	DWR_NA0035_15_c_2012_71			
Action/Comments				
Inspector Comments: Vegetation growth, cat tails, bushes, or saplings block 25% of the channel.

View of the channel looking upstream. Summer 2020.

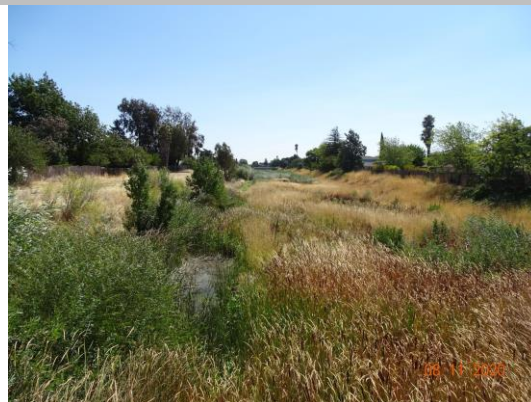
Photo 1 of 1 : CH_2020_NA0035_15_76_20200812_00030.jpg

View of the channel looking downstream. Summer 2020.

Rating **	M	Issue No.	76	GPS Lat/Long
Issue Type +	Ma	Location *		38.253325 °
Category	Rivers, Channels & Designated Flood			-122.014818 °
Item	Vegetation & Obstructions			
DWR ID	DWR_NA0035_15_c_2012_76			
Action/Comments				
Inspector Comments: Clear tules and other woody vegetation from the channel.

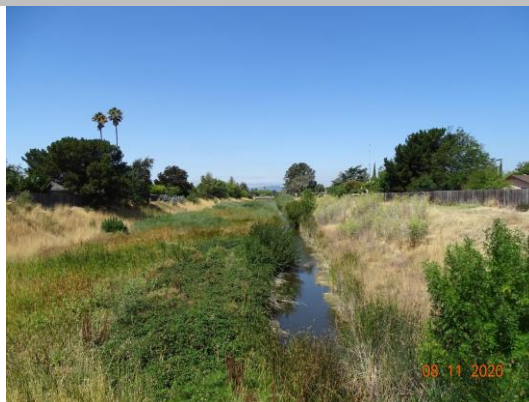
Photo 1 of 1 : CH_2020_NA0035_15_81_20200812_00029.jpg

Inspector Comments: Minimal, scattered obstructions or vegetation. The flow is not impeded.

View of the channel looking upstream. Summer 2020.

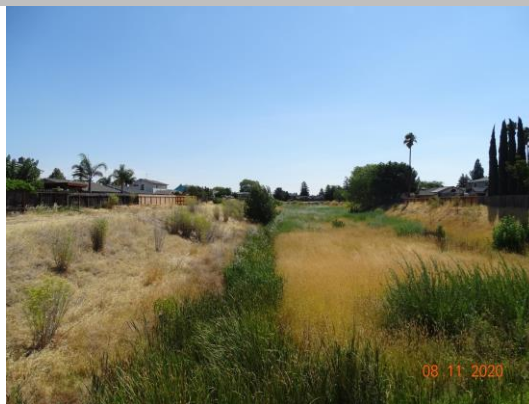
Photo 1 of 1 : CH_2020_NA0035_15_86_20200812_00028.jpg

Rating **	M	Issue No.	86	GPS Lat/Long
Issue Type +	Ma	Location *		38.253248 °
Category	Rivers, Channels & Designated Flood			-122.009732 °
Item	Vegetation & Obstructions			
DWR ID	DWR_NA0035_15_c_2012_86			
Action/Comments				
Inspector Comments: Vegetation growth (such as cat tails, bull rushes, bushes or saplings) or other obstructions block approximately 25% of the channel.

View of the channel looking downstream. Summer 2020.

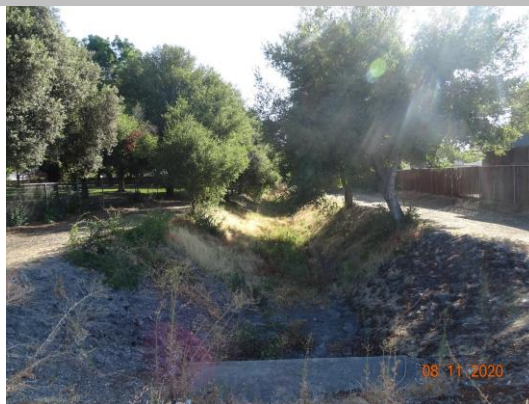
Photo 1 of 1 : CH_2020_NA0035_17_1_20200812_00021.jpg

Rating **	A	Issue No.	1	GPS Lat/Long
Issue Type +	Ma	Location *		38.256296 °
Category	Rivers, Channels & Designated Flood			-122.073705 °
Item	Vegetation & Obstructions			
DWR ID	DWR_NA0035_17_c_2012_1			
Action/Comments				
Inspector Comments: Minimal, scattered obstructions or vegetation. The flow is not impeded.

View of the channel looking upstream. Summer 2020.

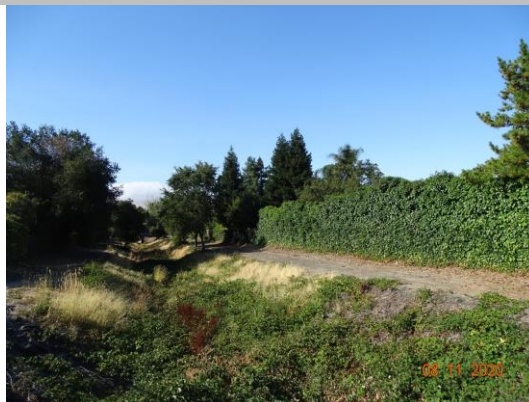
Photo 1 of 1 : CH_2020_NA0035_17_6_20200812_00022.jpg

View of the channel looking downstream. Summer 2020.

Inspector Comments: Blackberry bushes should be cleared out.

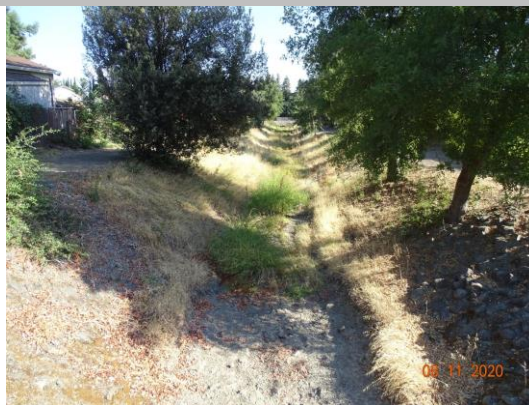
Photo 1 of 1 : CH_2020_NA0035_17_11_20200812_00023.jpg

Check Point / View				
Springfield Dr. / Up				
Rating **	A	Issue No.	11	GPS Lat/Long
Issue Type +	Ma	Location *		38.254594 °
Category	Rivers, Channels & Designated Flood			-122.073608 °
Item	Vegetation & Obstructions			
DWR ID	DWR_NA0035_17_c_2012_11			
Action/Comments				
Inspector Comments: Minimal, scattered obstructions or vegetation. The flow is not impeded.

View of the channel looking upstream. Summer 2020.

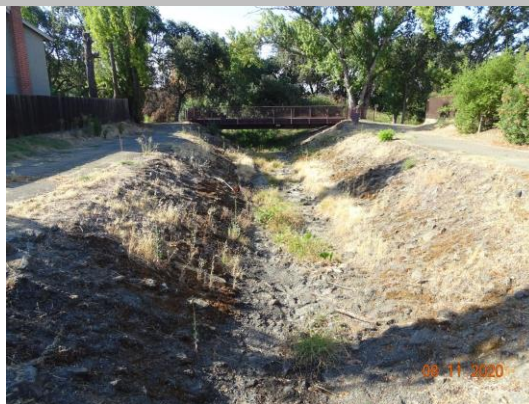
Photo 1 of 1 : CH_2020_NA0035_17_16_20200812_00024.jpg

Rating **	A	Issue No.	16	GPS Lat/Long
Issue Type +	Ma	Location *		38.254594 °
Category	Rivers, Channels & Designated Flood			-122.073608 °
Item	Vegetation & Obstructions			
DWR ID	DWR_NA0035_17_c_2012_16			
Action/Comments				
Inspector Comments: Minimal, scattered obstructions or vegetation. The flow is not impeded.

View of the channel looking downstream. Summer 2020.

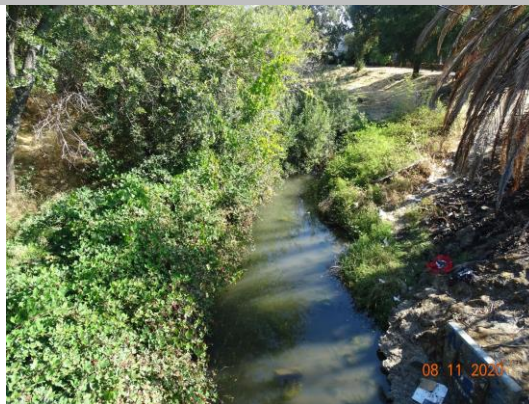
Photo 1 of 1 : CH_2020_NA0035_17_21_20200812_00025.jpg

Inspector Comments: Minimal, scattered obstructions or vegetation. The flow is not impeded.

View of the channel looking upstream. Summer 2020.

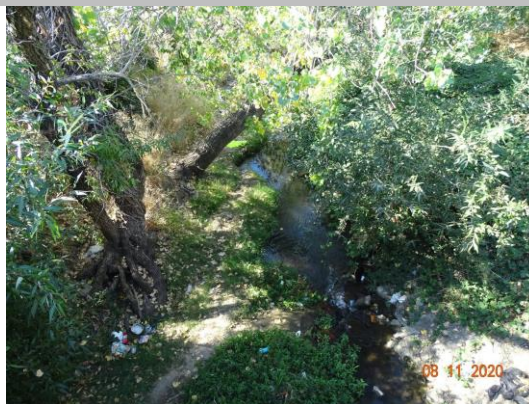
Photo 1 of 1 : CH_2020_NA0035_17_26_20200812_00027.jpg

Rating **	A	Issue No.	26	GPS Lat/Long
Issue Type +	Ma	Location *		38.249840 °
Category	Rivers, Channels & Designated Flood			-122.072644 °
Item	Vegetation & Obstructions			
DWR ID	DWR_NA0035_17_c_2012_26			
Action/Comments				
Inspector Comments: Minimal, scattered obstructions or vegetation. The flow is not impeded.

View of the channel looking downstream. Summer 2020.

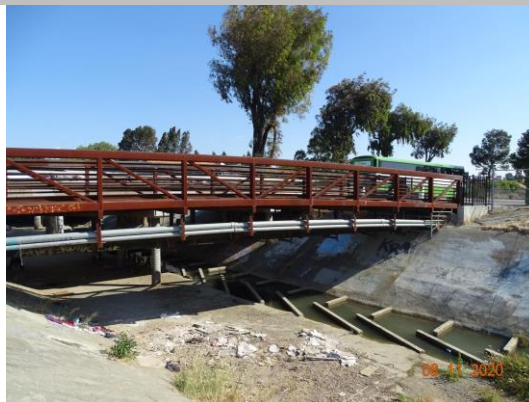
Photo 1 of 1 : CH_2020_NA0035_17_31_20200812_00028.jpg

Inspector Comments: Minimal, scattered obstructions or vegetation. The flow is not impeded.

View of the channel looking upstream. Summer 2020.

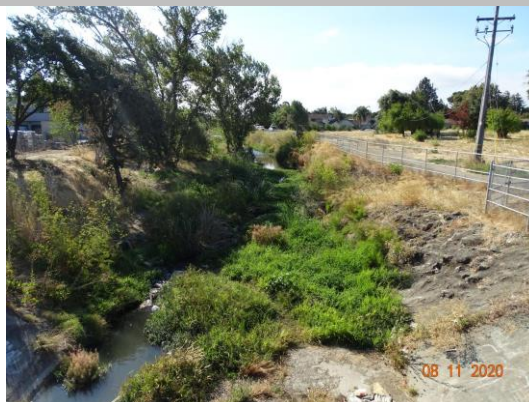
Photo 1 of 1 : CH_2020_NA0035_17_36_20200812_00029.jpg

Check Point / View				
Auto Mall Parkway / Down				
Rating **	A	Issue No.	36	GPS Lat/Long
Issue Type +	Ma	Location *		38.247722 °
Category	Rivers, Channels & Designated Flood			-122.072105 °
Item	Vegetation & Obstructions			
DWR ID	DWR_NA0035_17_c_2012_36			
Action/Comments				
Inspector Comments: Minimal, scattered obstructions or vegetation. The flow is not impeded.

View of the channel looking downstream. Summer 2020.

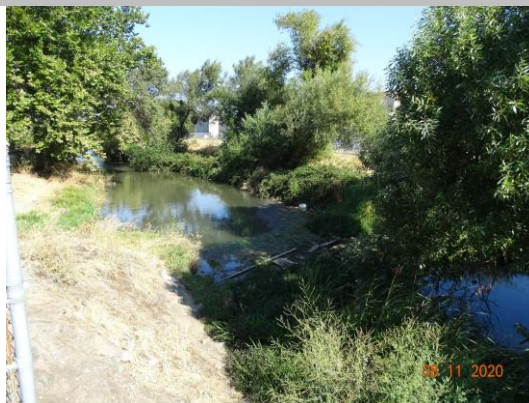
Photo 1 of 1 : CH_2020_NA0035_17_41_20200812_00031.jpg

Inspector Comments: Minimal, scattered obstructions or vegetation. The flow is not impeded.

View of the channel looking upstream. Summer 2020.

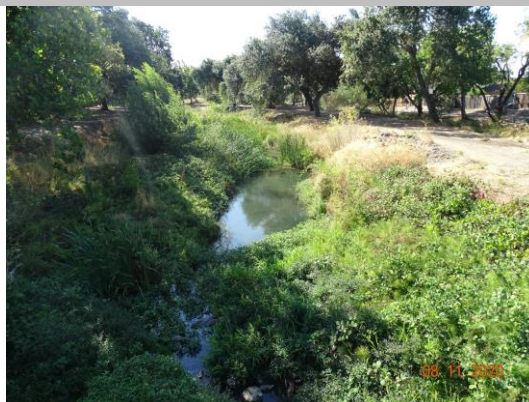
Photo 1 of 1 : CH_2020_NA0035_17_46_20200812_00032.jpg

Inspector Comments: Minimal, scattered obstructions or vegetation. The flow is not impeded.

View of the channel looking downstream. Summer 2020.

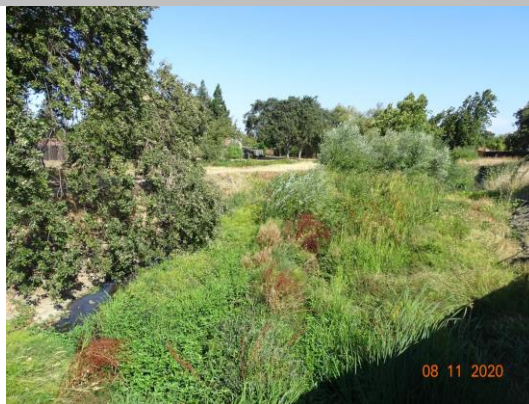
Photo 1 of 1 : CH_2020_NA0035_17_51_20200812_00033.jpg

Rating **	M	Issue No.	51	GPS Lat/Long
Issue Type +	Ma	Location *		38.243702 °
Category	Rivers, Channels & Designated Flood			-122.066538 °
Item	Vegetation & Obstructions			
DWR ID	DWR_NA0035_17_c_2012_51			
Action/Comments				
Inspector Comments: There is vegetation within the channel that approxiamtely blocks 25% of capacity.

View of the channel looking upstream. Summer 2020.

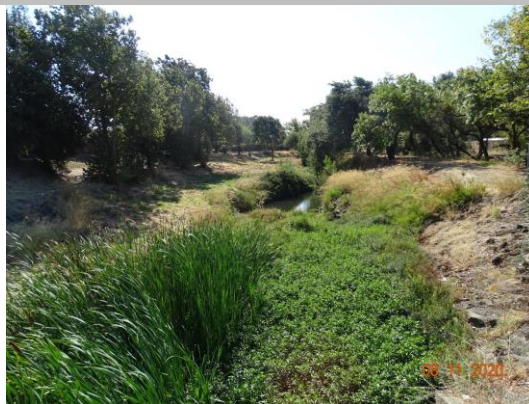
Photo 1 of 1 : CH_2020_NA0035_17_56_20200812_00034.jpg

Inspector Comments: Minimal, scattered obstructions or vegetation. The flow is not impeded.

View of the channel looking downstream. Summer 2020.

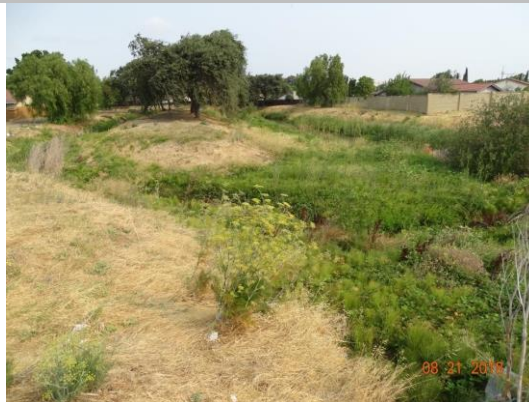
Photo 1 of 1 : CH_2020_NA0035_17_61_20200715_00015.jpg

Inspector Comments: Unable to get photo due to gate access, however the channel was visually inspected from Hwy 12 and the capacity is not impeded.

View of the channel, looking upstream. Summer 2018.

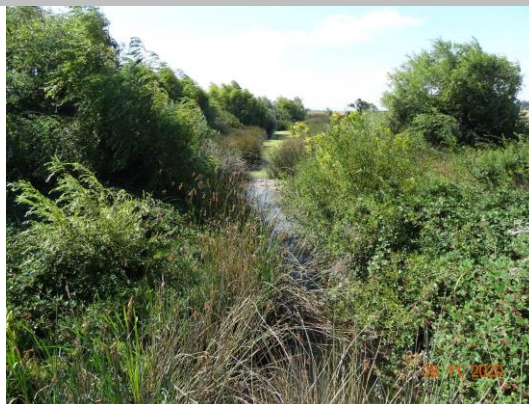
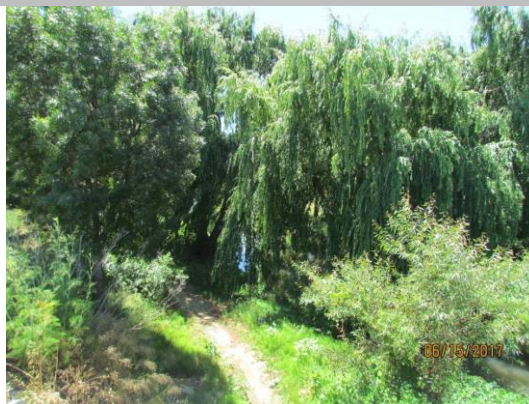
Rating **	A	Issue No.	66	GPS Lat/Long
Issue Type +	Ma	Location *		38.240590 °
Category	Rivers, Channels & Designated Flood			-122.062413 °
Item	Vegetation & Obstructions			
DWR ID	DWR_NA0035_17_c_2012_66			
Action/Comments				
Inspector Comments: Unable to get photo due to gate access, however the channel was visually inspected from Hwy 12 and the capacity is not impeded.

View of the channel looking downstream from the railroad bridge.
Summer 2020.

View of the channel looking downstream from Highway 12. Summer 2017.

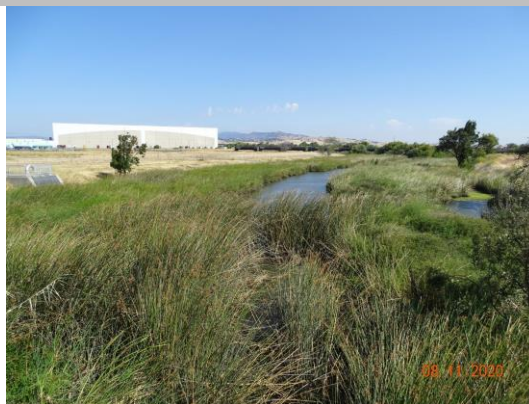
Photo 1 of 1 : CH_2020_NA0035_17_71_20200812_00036.jpg

Rating **	A	Issue No.	71	GPS Lat/Long
Issue Type +	Ma	Location *		38.233331 °
Category	Rivers, Channels & Designated Flood			-122.058608 °
Item	Vegetation & Obstructions			
DWR ID	DWR_NA0035_17_c_2012_71			
Action/Comments				
Inspector Comments: Some vegetation present, but it does not appear to impede the flow.

View of the channel looking upstream. Summer 2020.

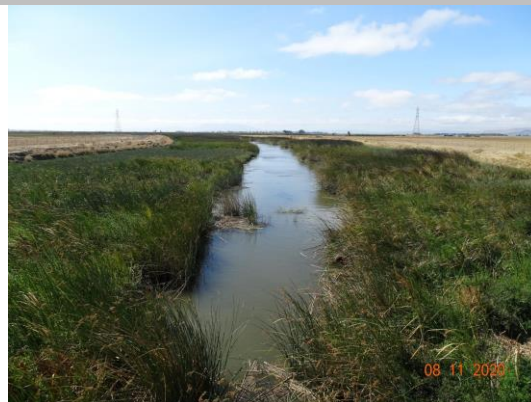
Photo 1 of 1 : CH_2020_NA0035_17_76_20200812_00037.jpg

Inspector Comments: Minimal, scattered obstructions or vegetation. The flow is not impeded.

View of the channel looking downstream. Summer 2020.

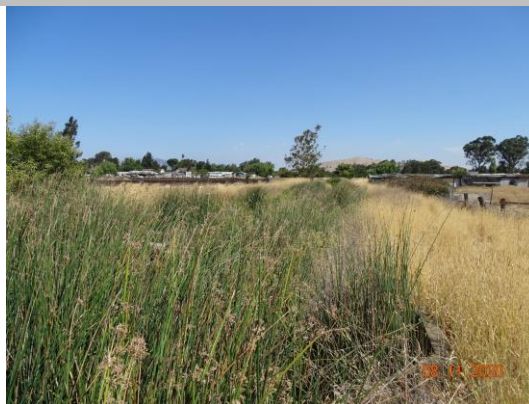
Photo 1 of 1 : CH_2020_NA0035_14_1_20200812_00020.jpg

Rating **	M	Issue No.	1	GPS Lat/Long
Issue Type +	Ma	Location *		38.253280 °
Category	Rivers, Channels & Designated Flood			-122.000670 °
Item	Vegetation & Obstructions			
DWR ID	DWR_NA0035_14_c_2012_1			
Action/Comments				
Inspector Comments: Vegetation blocks approximately 25% of the capacity.

View of the channel looking upstream. Summer 2020.

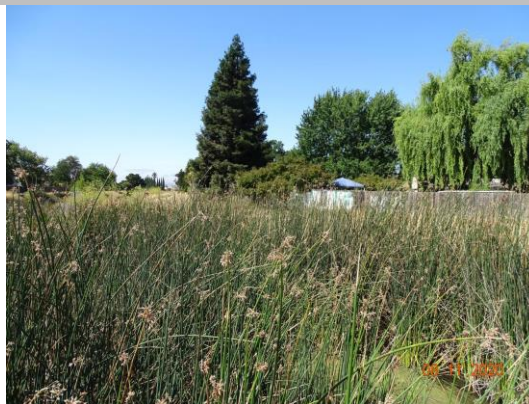
Photo 1 of 1 : CH_2020_NA0035_14_6_20200812_00019.jpg

Inspector Comments: Vegetation blocks approximately 25% of the capacity.

View of the channel looking downstream. Summer 2020.

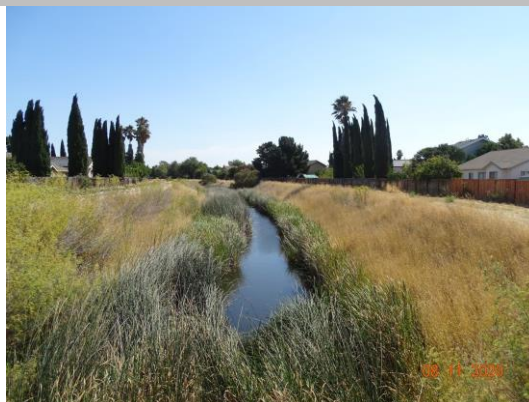
Photo 1 of 1 : CH_2020_NA0035_14_11_20200812_00018.jpg

Inspector Comments: Minimal vegetation in the channel. Does not reduce capacity.

View of the channel looking upstream. Summer 2020.

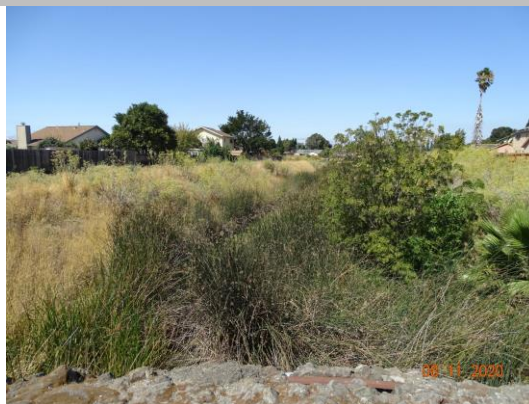
Photo 1 of 1 : CH_2020_NA0035_14_16_20200812_00017.jpg

Rating **	M	Issue No.	16	GPS Lat/Long
Issue Type +	Ma	Location *		38.250738 °
Category	Rivers, Channels & Designated Flood			-122.004355 °
Item	Vegetation & Obstructions			
DWR ID	DWR_NA0035_14_c_2012_16			
Action/Comments				
Inspector Comments: Cattails/bull rush need to be sprayed or removed at street crossing. Try to maintain 50 ft. to 100 ft. clearance.

View of the channel looking downstream. Summer 2020.

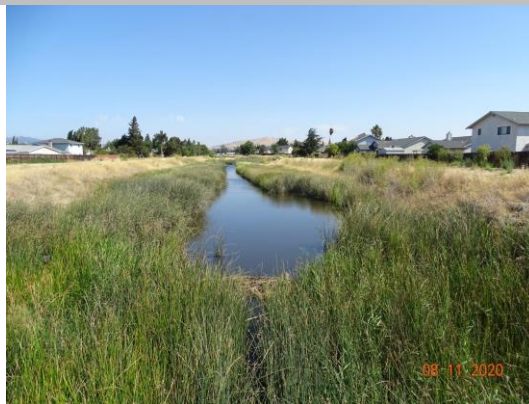
Photo 1 of 1 : CH_2020_NA0035_14_21_20200812_00016.jpg

Inspector Comments: Minimal scattered obstruction or vegetation. The flow is not impeded.

View of the channel looking upstream. Summer 2020.

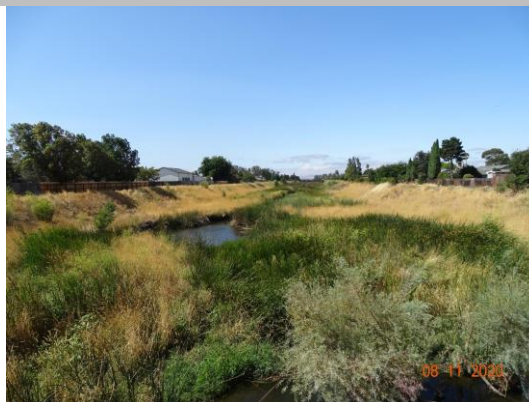
Photo 1 of 1 : CH_2020_NA0035_14_26_20200812_00015.jpg

View of the channel looking downstream. Summer 2020.

Inspector Comments: Clear out grass and woody vegetation.

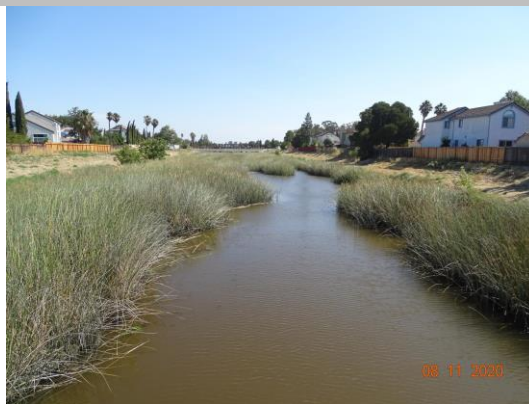
Photo 1 of 1 : CH_2020_NA0035_14_31_20200812_00014.jpg

Rating **	A	Issue No.	31	GPS Lat/Long
Issue Type +	Ma	Location *		38.241537 °
Category	Rivers, Channels & Designated Flood			-122.012077 °
Item	Vegetation & Obstructions			
DWR ID	DWR_NA0035_14_c_2012_31			
Action/Comments				
Inspector Comments: Minimal, scattered obstructions or vegetation. The flow is not impeded.

View of the channel looking upstream. Summer 2020.

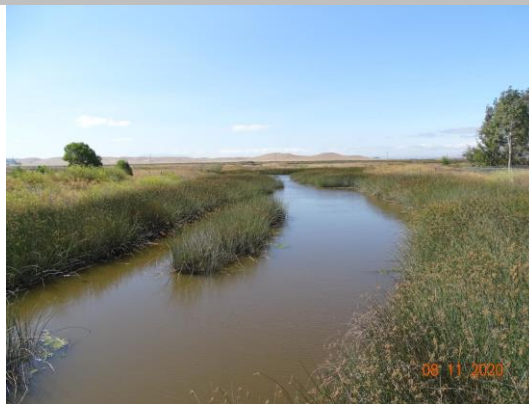
Photo 1 of 1 : CH_2020_NA0035_14_36_20200812_00013.jpg

Inspector Comments: Minimal, scattered obstructions or vegetation. The flow is not impeded.

View of the channel looking downstream. Summer 2020.

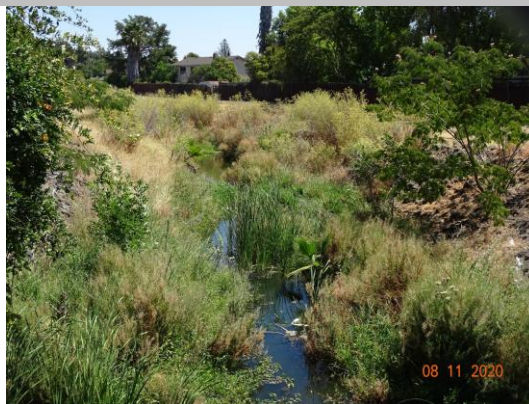
Photo 1 of 1 : CH_2020_NA0035_16_6_20200812_00017.jpg

Rating **	A	Issue No.	6	GPS Lat/Long
Issue Type +	Ma	Location *		38.280585 °
Category	Rivers, Channels & Designated Flood			-122.034039 °
Item	Vegetation & Obstructions			
DWR ID	DWR_NA0035_16_c_2012_6			
Action/Comments				
Inspector Comments: Minimal, scattered obstructions or vegetation. The flow is not impeded.

View of the channel looking downstream. Summer 2020.

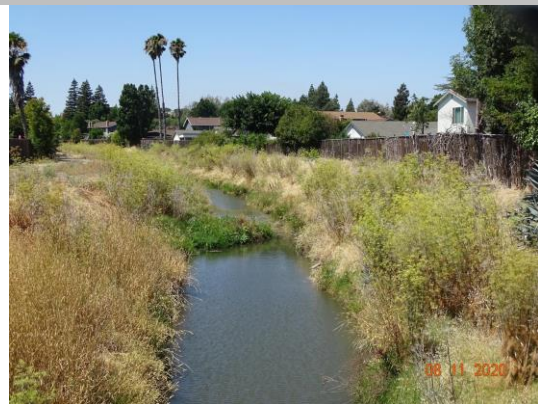
Photo 1 of 1 : CH_2020_NA0035_16_11_20200812_00016.jpg

Inspector Comments: Minimal, scattered obstructions or vegetation. The flow is not impeded. Cactus should be removed.

View of the channel looking upstream. Summer 2020.

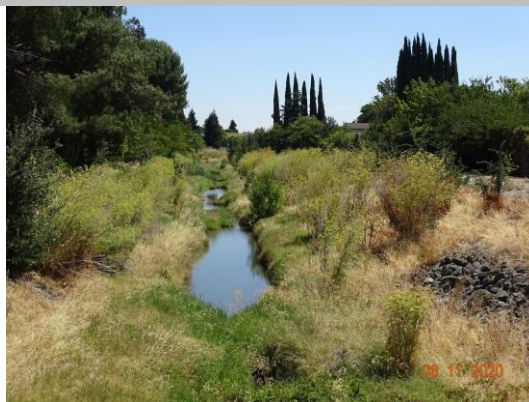
Photo 1 of 1 : CH_2020_NA0035_16_16_20200812_00015.jpg

Check Point / View				
Camrose Ave / Down				
Rating **	A	Issue No.	16	GPS Lat/Long
Issue Type +	Ma	Location *		38.281544 °
Category	Rivers, Channels & Designated Flood			-122.030543 °
Item	Vegetation & Obstructions			
DWR ID	DWR_NA0035_16_c_2012_16			
Action/Comments				
Inspector Comments: Minimal, scattered obstructions or vegetation. The flow is not impeded.

View of the channel looking downstream. Summer 2020.

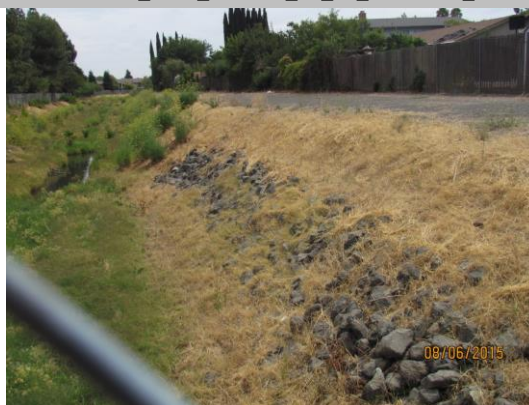
Photo 1 of 1 : CH_2020_NA0035_16_19_20200715_00004.jpg

Inspector Comments: Existing riprap protection is properly maintained and is undamaged. Riprap clearly visible.

View of the revetment on the right bank looking downstream. Summer 2015.

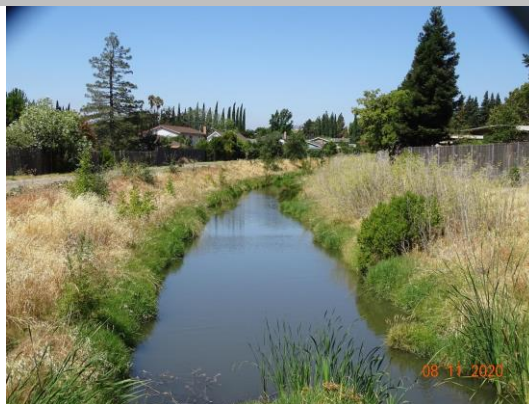
Photo 1 of 1 : CH_2020_NA0035_16_21_20200812_00014.jpg

Rating **	A	Issue No.	21	GPS Lat/Long
Issue Type +	Ma	Location *		38.280990 °
Category	Rivers, Channels & Designated Flood			-122.024750 °
Item	Vegetation & Obstructions			
DWR ID	DWR_NA0035_16_c_2012_21			
Action/Comments				
Inspector Comments: Minimal, scattered obstructions or vegetation. The flow is not impeded.

View of the channel looking upstream. Summer 2020.

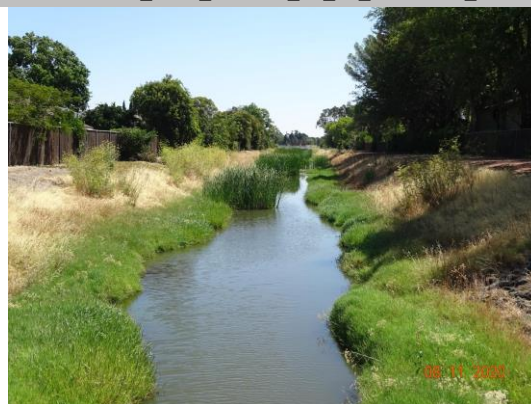
Photo 1 of 1 : CH_2020_NA0035_16_26_20200812_00013.jpg

Inspector Comments: Minimal, scattered obstructions or vegetation. The flow is not impeded.

View of the channel looking downstream. Summer 2020.

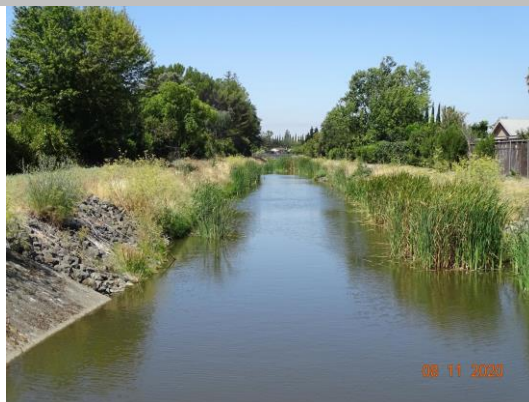
Photo 1 of 1 : CH_2020_NA0035_16_31_20200812_00012.jpg

Check Point / View				
Gulf Dr / Up				
Rating **	A	Issue No.	31	GPS Lat/Long
Issue Type +	Ma	Location *		38.281002 °
Category	Rivers, Channels & Designated Flood			-122.020570 °
Item	Vegetation & Obstructions			
DWR ID	DWR_NA0035_16_c_2012_31			
Action/Comments				
Inspector Comments: Minimal, scattered obstructions or vegetation. The flow is not impeded.

View of the channel looking upstream. Summer 2020.

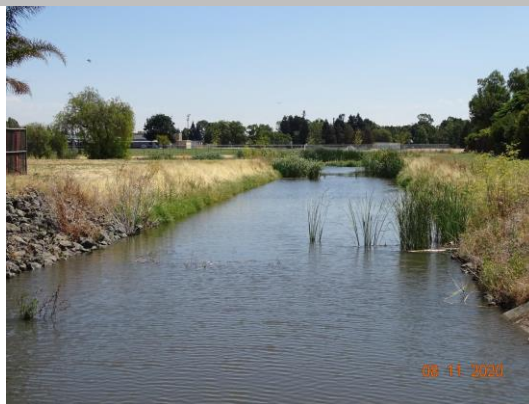
Photo 1 of 1 : CH_2020_NA0035_16_36_20200812_00011.jpg

Check Point / View				
Gulf Dr / Down				
Rating **	A	Issue No.	36	GPS Lat/Long
Issue Type +	Ma	Location *		38.280937 °
Category	Rivers, Channels & Designated Flood			-122.020629 °
Item	Vegetation & Obstructions			
DWR ID	DWR_NA0035_16_c_2012_36			
Action/Comments				
Inspector Comments: Minimal, scattered obstructions or vegetation. The flow is not impeded.

View of the channel looking downstream. Summer 2020.

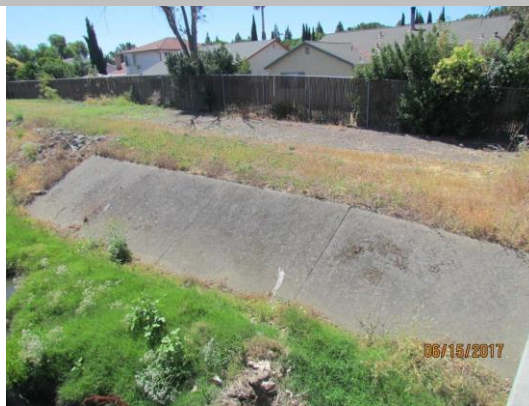
Photo 1 of 1 : CH_2020_NA0035_16_42_20200715_00010.jpg

Rating **	A	Issue No.	42	GPS Lat/Long
Issue Type +	Ma	Location *		38.281002 °
Category	Rivers, Channels & Designated Flood			-122.020570 °
Item	Concrete Surfaces			
DWR ID	DWR_NA0035_16_c_2017_42			
Action/Comments				
Inspector Comments: Concrete surface appears to be in good condition with no visible deficiencies.

View of concrete surface on right bank, looking downstream. Summer 2017.
